Manhole Inspection Summary

Manhole # S47MM_042MH

Insp Date: **3/9/10 1:24 PM**

Location Address: **Sinclair Ia**

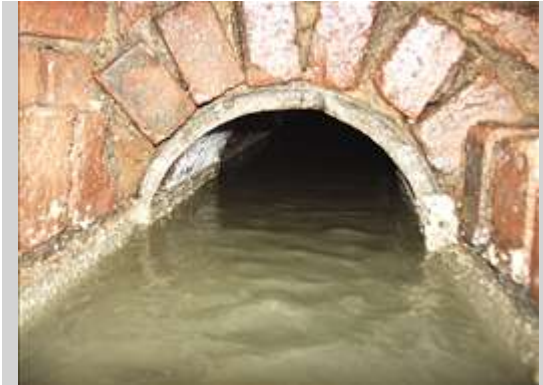
10 in. Circular Gravity Sewer
Pipe Out @ 12 O'Clock

Pipe Height: **14.4** (in.) Rod and Bar (Angled)
Pipe Material: **Clay** ☐ Pipe Lined
Invert Depth: **8.08** (ft.) Flow Characteristics: **Fast**
Deposits: ☒ None ☐ Mud ☐ Sludge ☐ Debris ☐ Grease
Silt Depth: (in.) Deposits Extent:
Infiltration: **None** Pipe Seal Cond: **Sound**

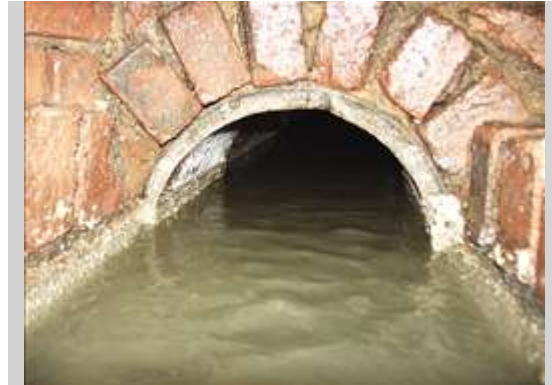
12 O'Clock Outflow
Pipe Out @ 12 O'Clock

Drop: **None**

Connects To: **Manhole**

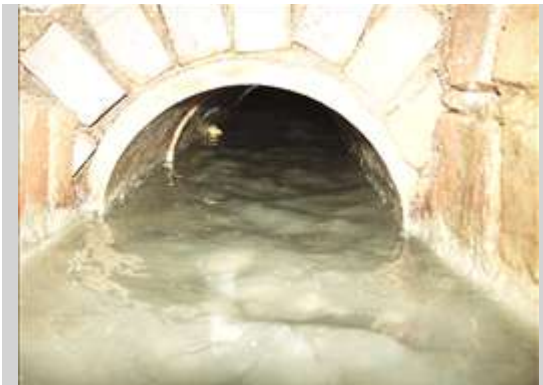
10 in. Circular Gravity Sewer
Pipe In @ 6 O'Clock

Pipe Height: **14.4** (in.) Rod and Bar (Angled)
Pipe Material: **Clay** ☐ Pipe Lined
Invert Depth: **8.08** (ft.) Flow Characteristics: **Fast**
Deposits: ☒ None ☐ Mud ☐ Sludge ☐ Debris ☐ Grease
Silt Depth: (in.) Deposits Extent:
Infiltration: **None** Pipe Seal Cond: **Sound**

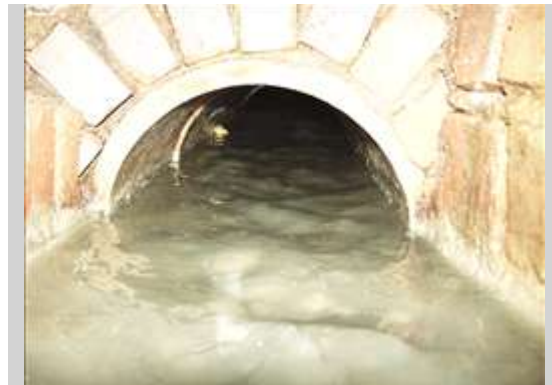
6 O'Clock Inflow
Pipe In @ 6 O'Clock

Drop: **None**

Connects To: **Manhole**

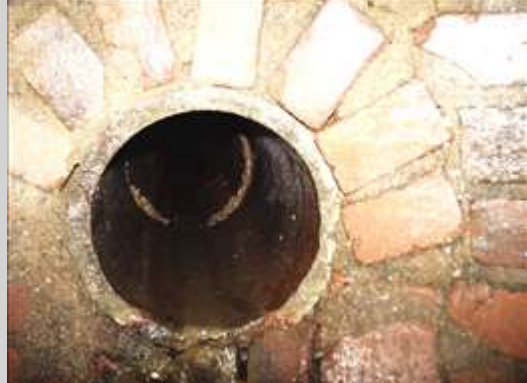
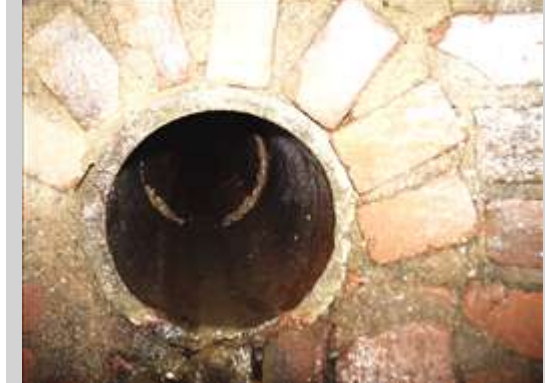
8 in. Circular Gravity Sewer

Pipe Height: **12** (in.) Rod and Bar (Angled)

Pipe Material: **Clay** ☐ Pipe Lined

Infiltration: **None** Pipe Seal Cond: **Sound**
